Safety Clicks

A TDI-Brooks Publication

January 1, 2018

Lessons from the El Faro Investigation

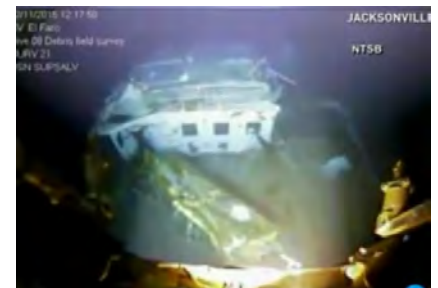
El Faro's bridge as seen from an ROV. The vessel was found at a depth of 15,000 feet.
