It's the Little Things...

“The Jenga Model of Safety”

NTSB report states: “American Dynasty was approaching the graving dock at Esquimalt in British Columbia, Canada, when it lost electrical power and propulsion control. The vessel veered off course and collided with a Canadian Navy frigate, HMCS Winnipeg, moored nearby. Both vessels sustained extensive structural damage, and the naval pier required repairs. Six shipyard workers suffered minor injuries.”

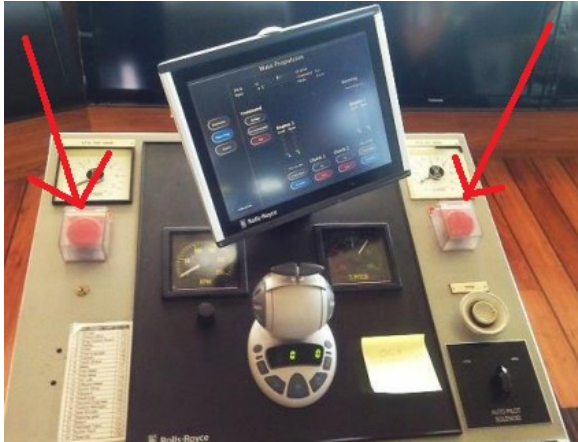
Oh, and no one thought to try the main engine emergency stop buttons on the bridge console. Damage was estimated at \$450,000. Read the full story by Bob Couttie at <http://maritimeaccident.org/2015/02/american-dynasty-lesson-rich-for-learning/>.

Section of the American Dynasty's bridge console with red emergency stop buttons. (Photo by NTSB)
