**Bridge Memorandum #37: Voyages and Position on Paper Charts**

# Bulk Carrier Struck Offshore Platform Missing from NOAA Navigation Charts, NTSB Finds

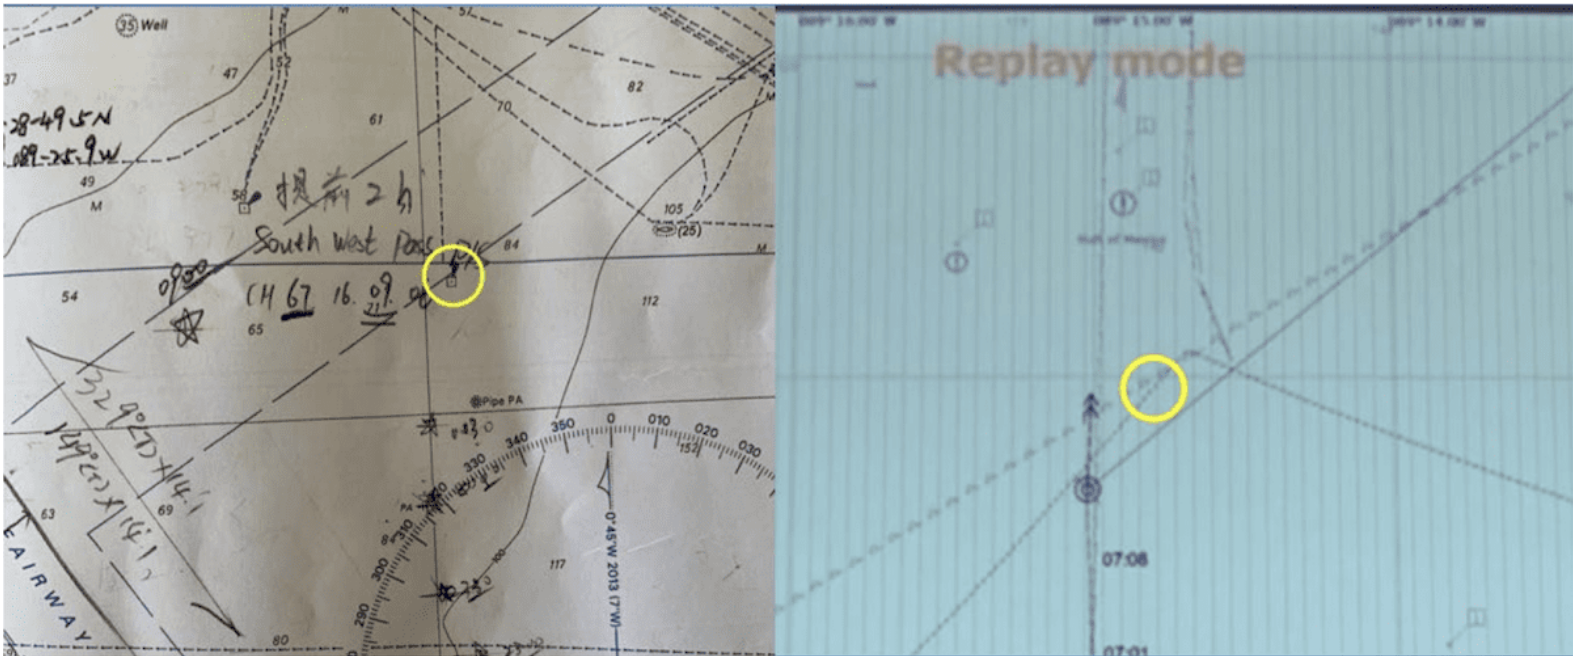
**Figure 6.** Navigation aids used by the *Ocean Princess* bridge team, with the location of platform SP-83A shown annotated by NTSB with a yellow circle (images are at different scales). A photo of the British Admiralty chart 3857 (left) and ECDIS screenshot from the *Ocean Princess* fed by NOAA ENC's (right), which were up to date at the time of the casualty. The British Admiralty chart shows SP-83A while the ECDIS image does not.

The NTSB found the platform SP-83A was not charted on the official U.S. National Oceanic and Atmospheric Administration (NOAA) electronic or paper navigation charts that provided the chart data to the ECDIS aboard the *Ocean Princess*. The platform, however, did appear on the British Admiralty paper chart that the mate on watch was using at the time of the accident.

The NTSB investigation revealed the platform had been shown on the NOAA charts starting in 1990, but for some unknown reason it was omitted starting in 2010 from two larger-scale U.S. paper charts. It then remained off the two paper charts and electronic navigation charts (ENCs) for over 11 years—until after the accident.

Following the incident, NOAA updated and corrected the electronic and paper charts that had been erroneously missing platform SP-83A.
