Swiss Cheese Safety By Shannon Smith

The information and details provided in the following story are a greatly summarized version of an investigation by the Marine Accident Investigations Branch (MAIB) of UK Merchant Shipping.

Fire aboard the Celtic Carrier

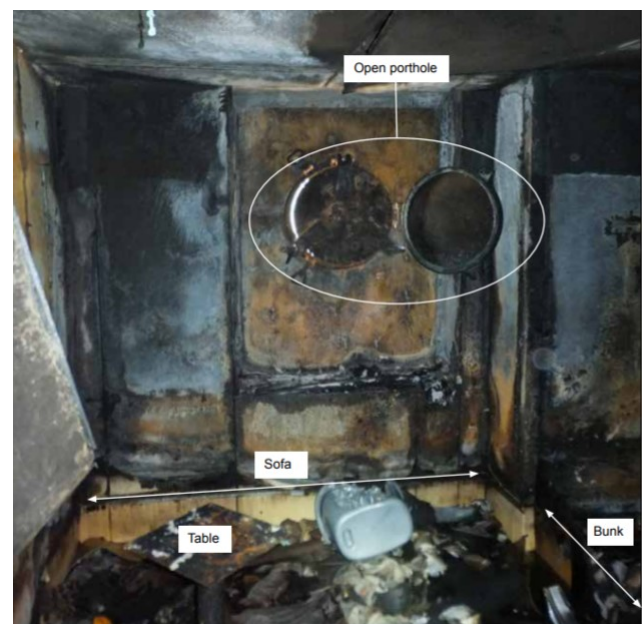
AB1's cabin had suffered fire damage to the upper third of the room and was still hot. AB2's cabin was still emitting considerable heat, so the door was not opened. The Motorman's room (between the two) appeared to have no major fire damage and most of the furniture was still intact.
