Mooring Line Safety

By Shannon Smith

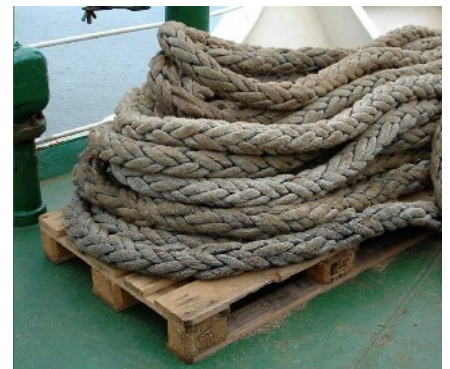
Ropes correctly stowed off deck

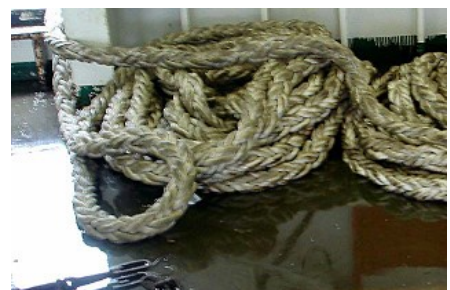
Ropes badly stored on wet deck

1. Lack of proper planning.
2. Poor or failed communications between bridge and crewman doing the mooring.
3. Crewmen were unaware of the locations of snapback zones or did not realize they were standing in unsafe positions.
4. Mooring ropes in poor condition
