Safety Clicks

A TDI-Brooks Publication

January 1, 2018

Lessons from the El Faro Investigation

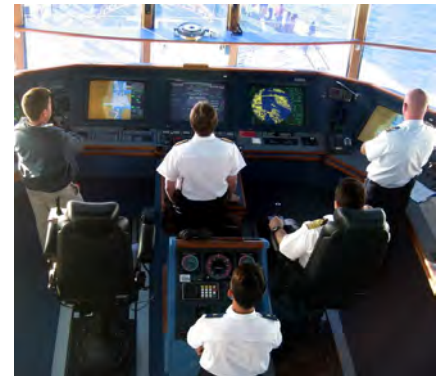
The cargo ship El Faro lost engine power in a Category 3 hurricane during its weekly run between San Juan, Puerto Rico and Jacksonville, Florida and sank near the Bahamas in 2015. None of the 33

A preliminary report submitted to the U.S. Coast Guard found that the El Faro was operating with a minimum margin of stability and would not have met standards for a ship built today.
