## **Inspection Guidelines for Plasma<sup>®</sup> Synthetic Ropes**

### **Puget Sound Rope Company**

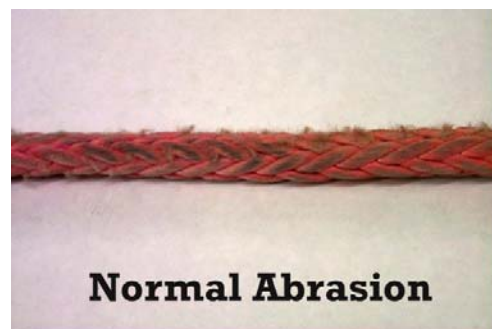
1. Repeated lateral abrasion against sharp edges. While HMPE is one of the most cut-resistant polymers available, metal can prove to be stronger than Plasma in a long-duration abrasion event. Signs of excess abrasion include strand pullouts, heavy fuzzing and cut strands in a single area, and localized bunching. It should be noted that normal light fuzzing of the Plasma rope surface is to be expected in normal use. This light fuzzing does not reduce the rated strength of the line, and actually creates a protective layer on the rope that helps to prevent further damage.

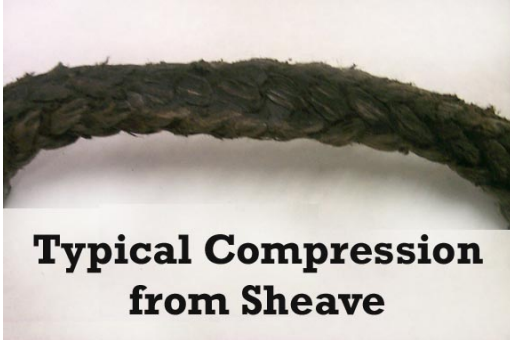
2. Plasma begins to lose strength above about 160 °F, and has a zero-strength temperature around 250 °C. Signs of high temperature damage include, melting, fused strands, and significantly reduced diameter. The fused strands should not be confused with high-tension compression of the rope which might appear similar. With standard urethane coatings, the rope can appear melted after high tension has been applied while the rope is bent around a surface. This is normally not melting and can be worked out with little effort. The rope strength is not affected.

The fused strands should not be confused with high-tension compression of the rope which might appear similar. With standard urethane coatings, the rope can appear melted after high tension has been applied while the rope is bent around a surface. This is normally not melting and can be worked out with little effort. The rope strength is not affected.

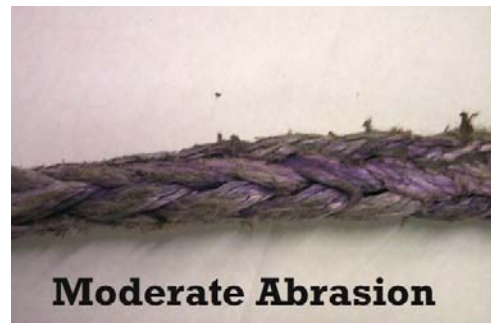
2. Visually inspect the entire length of rope for signs of abrasion, heavy fuzzing, stiff regions, fused or melted regions or thinned areas. Make note of any damaged areas.

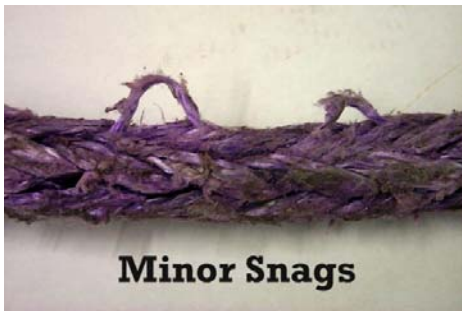
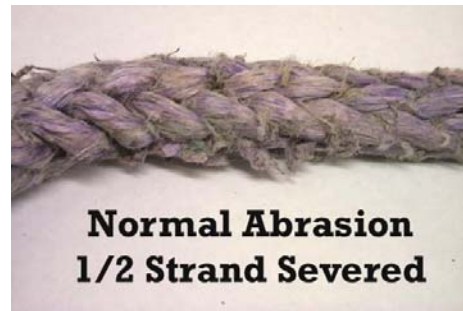
- a. More than 2 strands severed within a 2-foot segment
- b. Fused segment that is no longer flexible (strands not separable)
- c. Segment whose diameter is 20% less than other part of the rope
- d. Melting on one side that fuses one or more strands together
- e. Rope that has lengthened (between reference marks) by more than 10%
