Last Minute Risk Assessment– Looking out for #1

Failure to Assess Risk Results in 2 DOF Fatalities

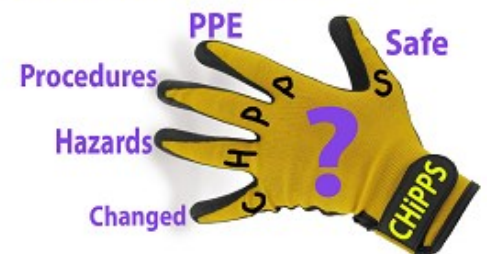
TDI Brooks Last Minute Risk Assessment

TDI has a **Last Minute Risk Assessment** known as **CHiPPS**, designed to help you take a minute to recognize hazards of any task. The image is a glove with each finger representing a question to ask yourself before starting work. (Write the letters on the knuckles of the gloves to help you remember.)

1. **Has anything changed?** (weather, sea state, gear, personnel)
2. **What are the hazards?** (heat, compressed air, electrical, chemical)
3. **Am I following procedures?** (SOPs, permits, conduct a JSA)
4. **Am I wearing proper PPE?** (per SOP, PPE matrix or JSA)
5. **How will I stay safe?** (know your escape route, don’t work alone, let someone know where you are, have communications available)

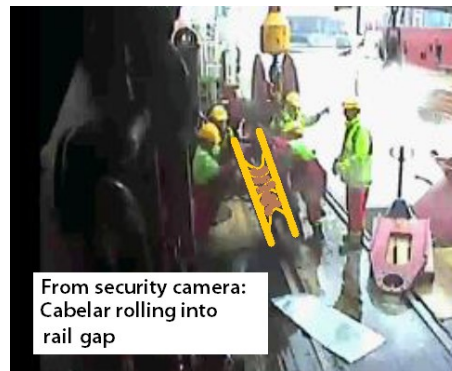
The first occurred when the Skandi Skansen was at the dock during a change out of a cabelar – a large, heavy piece of equipment resembling a 4.5 foot tall, roughly 2 ft wide metal wheel. This is a common operation on many DOF vessels.

A permit to work had been completed and a toolbox talk was held before work began. However, a risk assessment or JSA was not conducted. When the cabelar was lowered, it was not placed in the center of the chain locker lid as intended, but near a railing system of narrow, parallel deep channels on the deck. The crew did not check the landing position. As soon as the wheel was disconnected, they began manually rolling it into position.

The rim of the wheel rolled into the gap in the railing system, causing the wheel to fall against the bulkhead, pinning two crewmen. One escaped with only first aid injuries. The other was fatally crushed.

The investigation revealed that the cabelar was not handled by the intended vessel design method, the lifting and handling appliances to properly handle the cabelar were not available and there was inadequate design review by the company for this operation. In addition, the crew failed to comply with safe working practices and did not identify hazards and risks of the task.

The company issued a STOP WORK to the fleet stating that NO cabelars shall be free rolled. The corrective action plan included an evaluation and development of a safe method of installing cabelars throughout the fleet.
